# SAFETY OF WIND SYSTEMS

© M. Ragheb  
3/10/2012

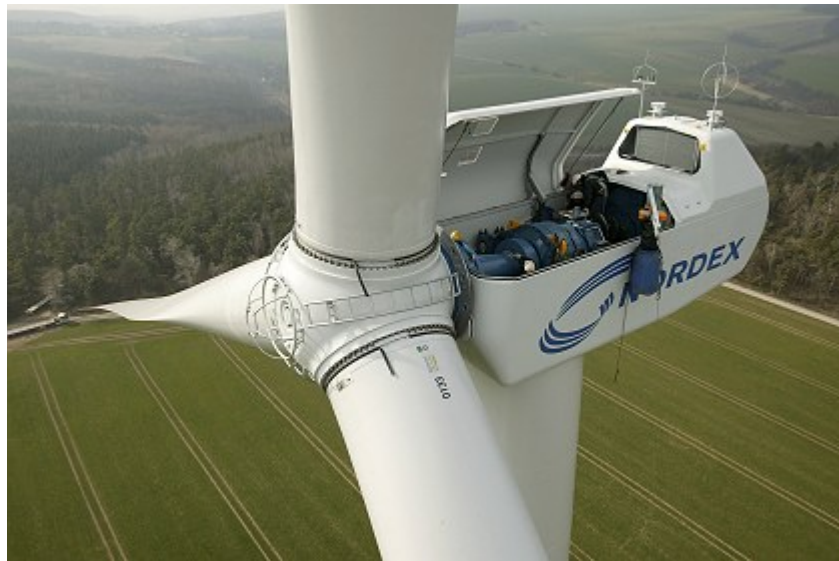
Figure 1. Maintenance at wind turbines nacelles involves work at about 100 meters height. Source: Getty, Nordex.

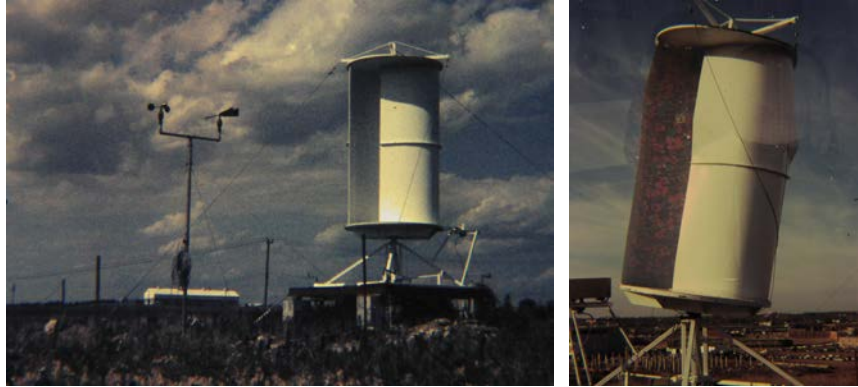
Figure 4. High winds damage effect on an experimental Savonius design wind turbine at Kansas State University, KSU.

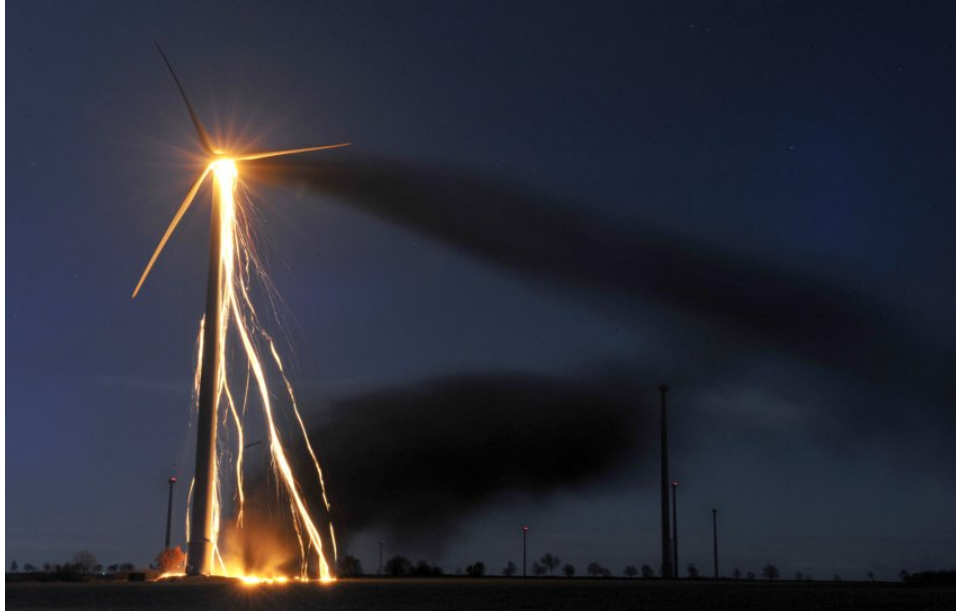
Figure 5. Wind turbine with ignited leaking lubrication oil near Uelzen, Lower Saxony, Germany, December 2, 2009. Source: DPA.

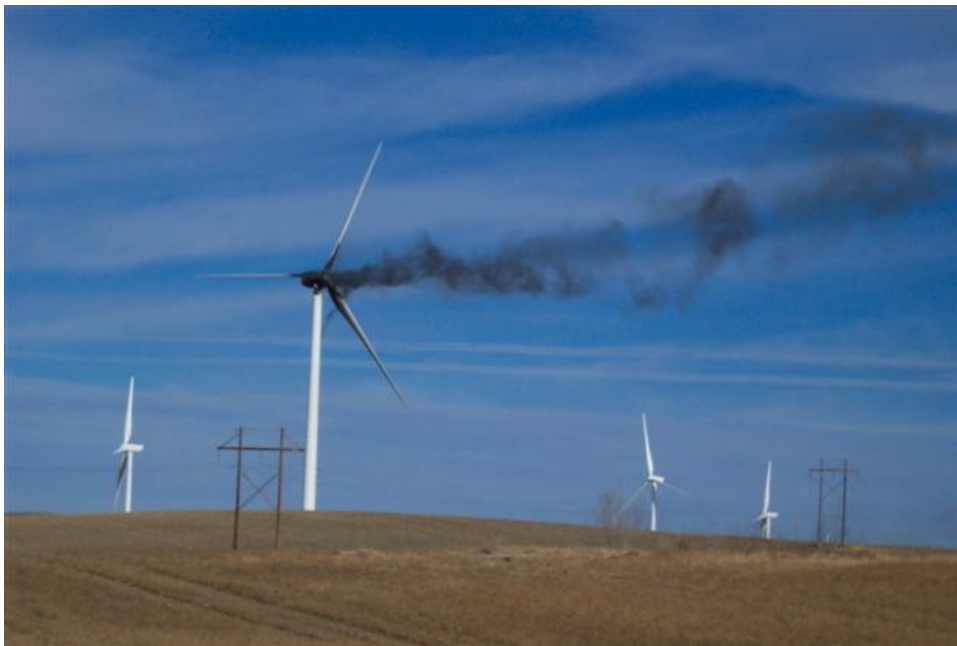
Figure 6. Wind turbine nacelle fire near Bloomingdale, Minnesota, USA, 2008.

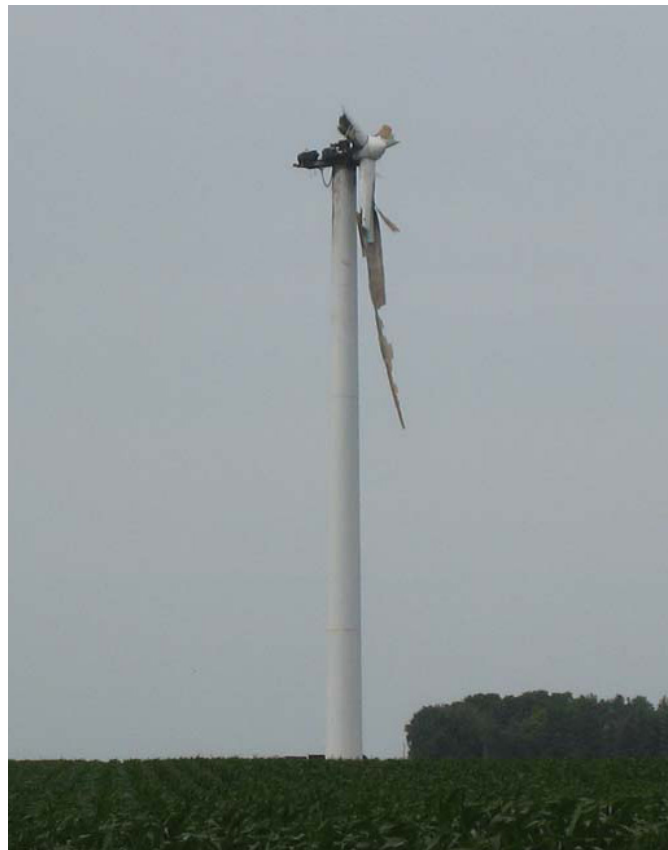
Figure 7. Lightning strike damage on a wind turbine in southern Minnesota, USA, resulted in the destruction of the nacelle and the rotor blades.

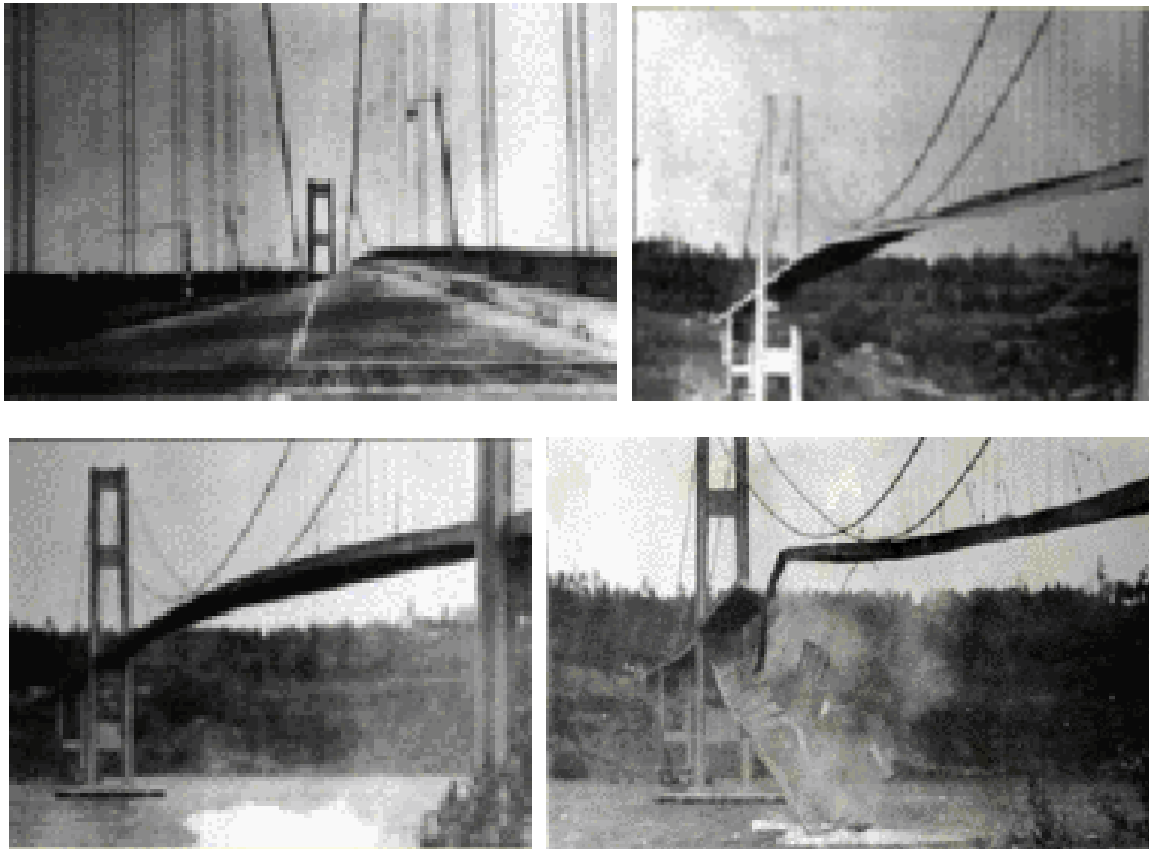
Figure 8. Torsional flutter aeroelasticity failure of the Tacoma Narrows Bridge, State of Washington, USA, 1940.

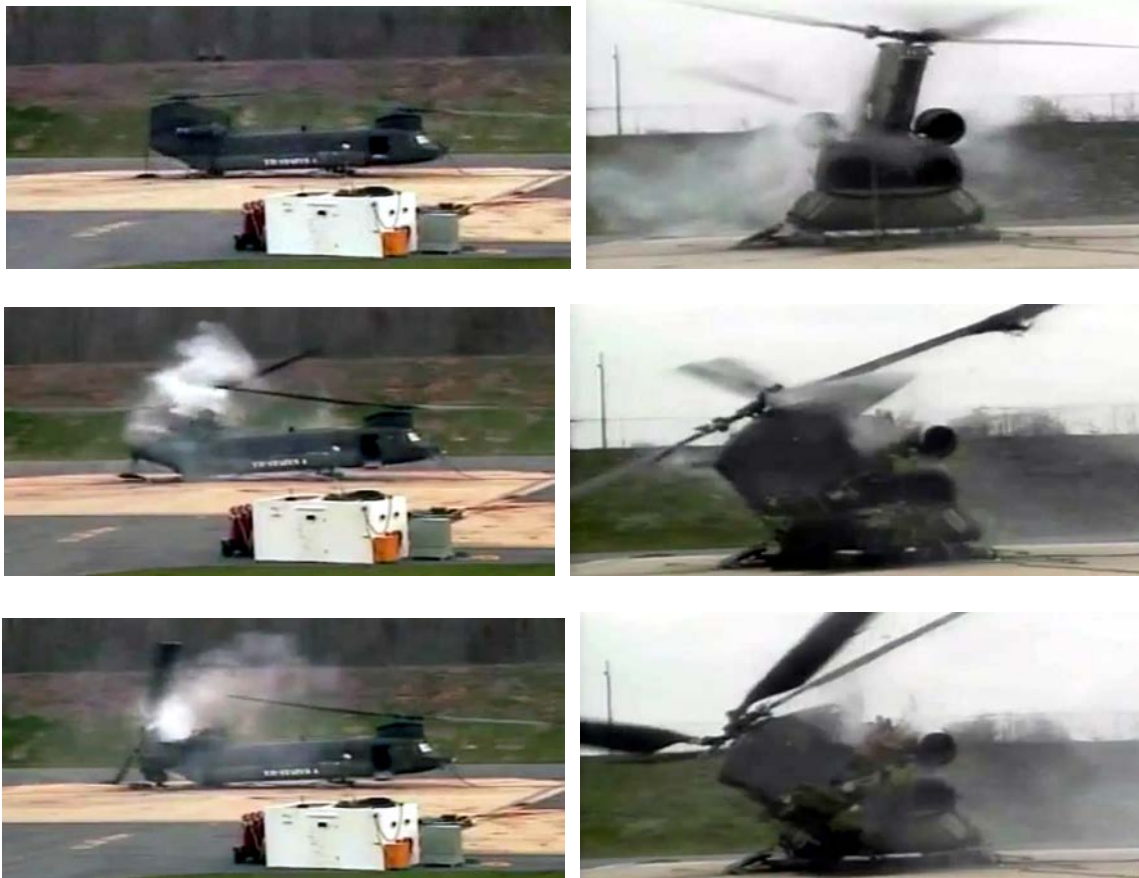
Figure 9. Resonance failure testing of helicopter blades.

A related issue is the possible resonant frequency failure phenomenon observed in the failure of helicopter systems.

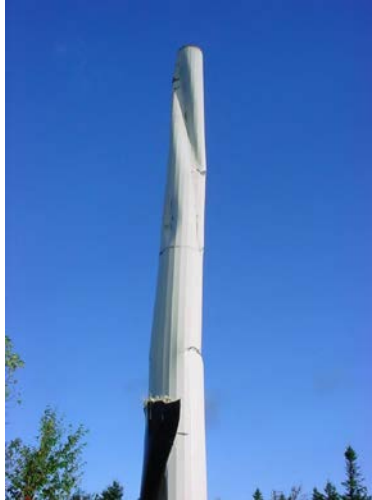
Figure 10. Turbine collapse in high wind conditions at the Searsburg, Vermont wind facility, September 15, 2008.

Turbine collapse occurred in high wind conditions at the Searsburg, Vermont wind facility on September 15, 2008. One of the rotor blades hit the base causing the tower to buckle and the nacelle and rotor assembly to crash to the ground.

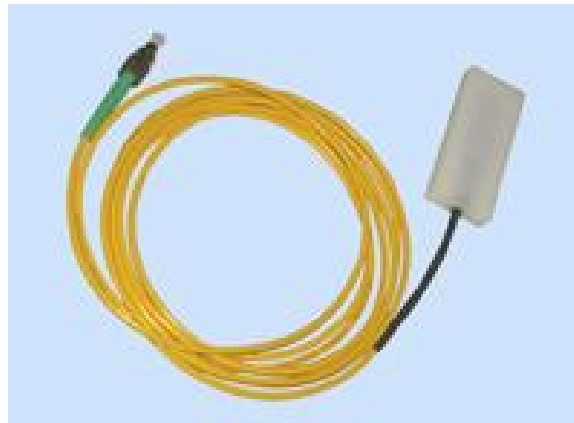
Figure 11. Fiber optics vibration sensor. Source: VFT VibroFibre.

Wind turbines are equipped with a vibration sensor located inside their structural tower. It consists of a ball bearing sitting on a ring. The ball bearing is connected to a disconnect switch through a chain that would turn the turbine off in case of excessive vibration. Fiber optics vibration sensors are used within the electrical components enclosures.

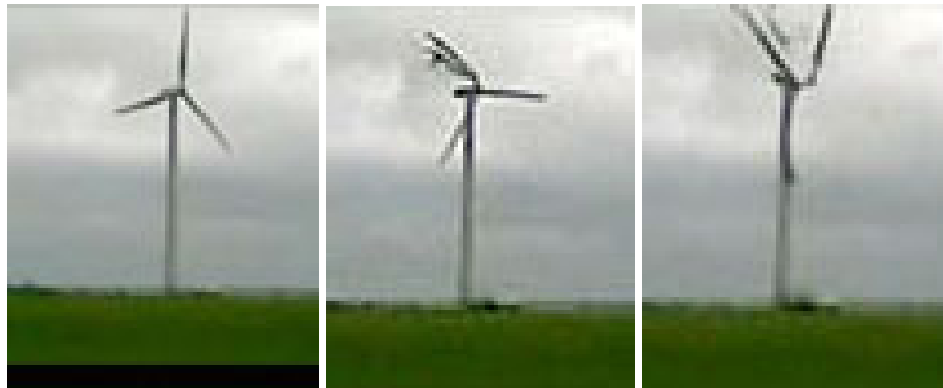
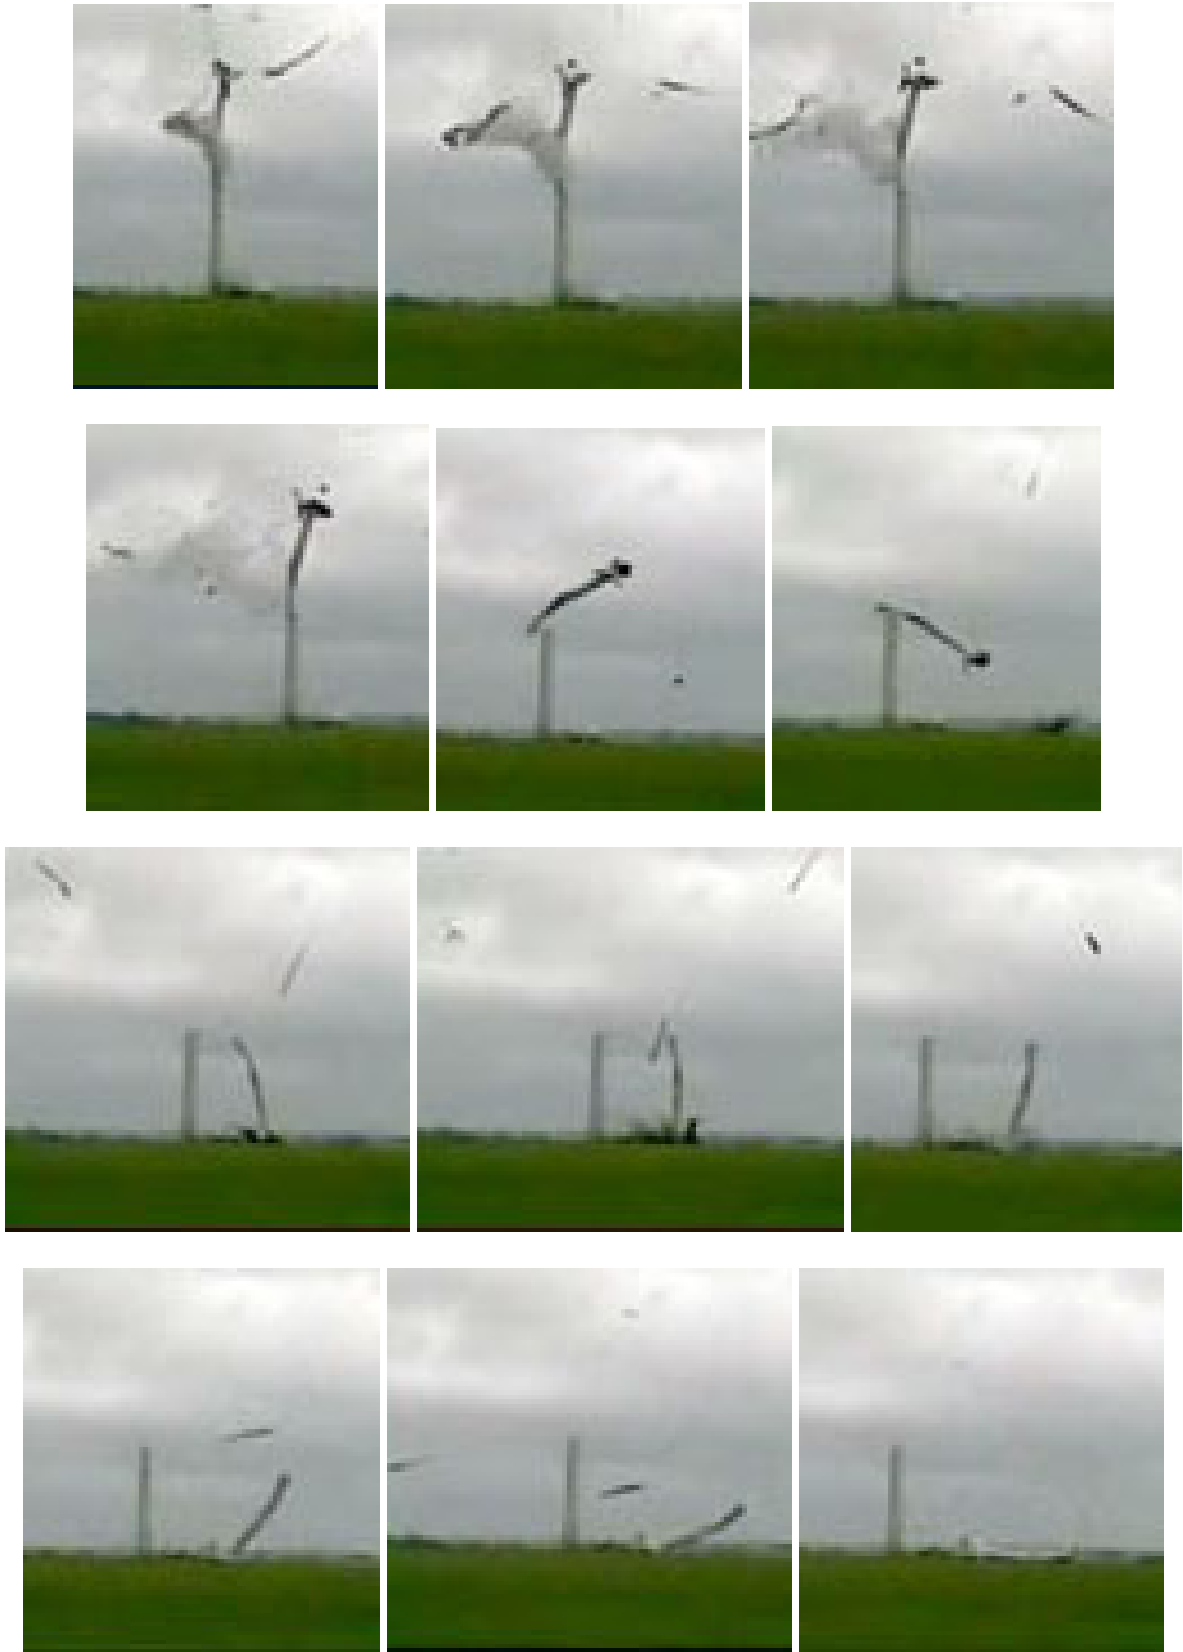
Figure 12. Runaway turbine disintegration clip sequence from video caused by failure of

brake system, 2008. Notice how an initiating event of a single blade failure evolved into a failure sequence where the unbalanced nacelle and hub caused another failed blade to hit the structural tower, slicing it and causing it to collapse while the disintegrated rotor blades were ejected away. Source: UTube.

A possible initiating event for overspeed failure is a generator overheating or being disconnected from the grid. The accident sequence that follows involves the inability of the generator to brake the rotation of the rotor. The rotor would start accelerating in its rotation within seconds of the initiating event.

To prevent such an accident sequence an overspeed protection system is essential. Safety regulations specify that such a system must have two independent fail-safe brake mechanisms to stop the turbine.

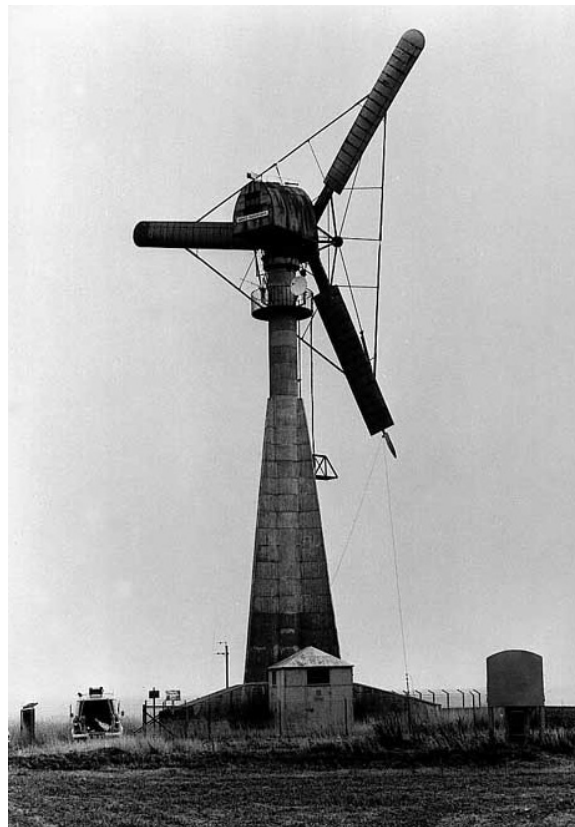
Figure 13. Emergency rotor tip brakes for the Gedser stall controlled wind turbine.  
Source: Danish Wind Turbine Manufacturers Association.

The Gedser wind turbine design was equipped with emergency rotor tip brakes.

To make them fail-safe and operable in the case of electrical power failure, those devices are designed to be spring loaded and are automatically activated if the hydraulic system in the wind turbine loses its pressure. Once the hazardous situation is over, the hydraulic system would restore the blades tips or the whole blades to their original operational state.

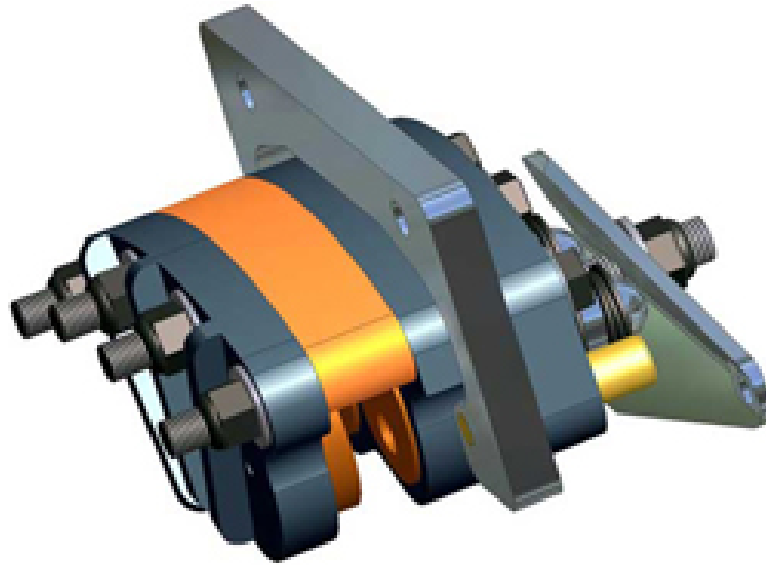
Figure 14. Wind turbine mechanical caliper disc brake. Source: WC Branham.

For reliability, a mechanical brake supplements the aerodynamic braking system in wind turbines. It also doubles as a parking brake when a stall controlled turbine is stopped. Its design draws on automobile brakes designs, but on a larger size scale.

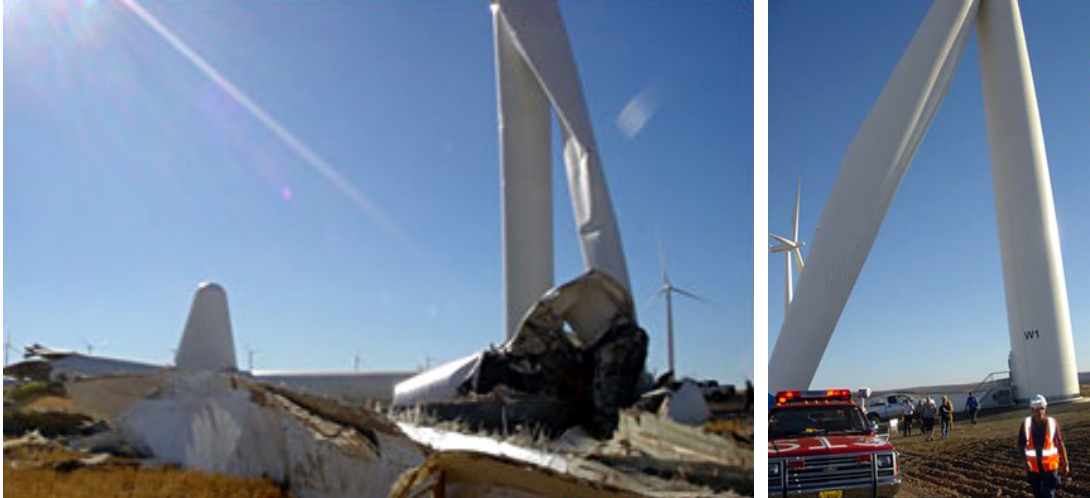
Figure 15. Tower collapse of a wind turbine. Wasco, Oregon, August 27, 2007.

A tower collapse in Eastern Oregon caused a person to fall to his death and another to be injured in August of 2007. The worker killed in the incident was at the top of a turbine tower when the turbine tower buckled about halfway up and toppled over. The injured person was inside of the tower at the time while the third worker, who escaped injury, was at the base. The turbine had been in operation for 500 hours and the workers were doing a routine inspection. The turbine was part of the Klondike III wind project, located near Wasco which generates 221 MW of electricity. It was using a mix of 44 Siemens 2.3 MW wind turbines and 80 General Electric 1.5 MW wind turbines.

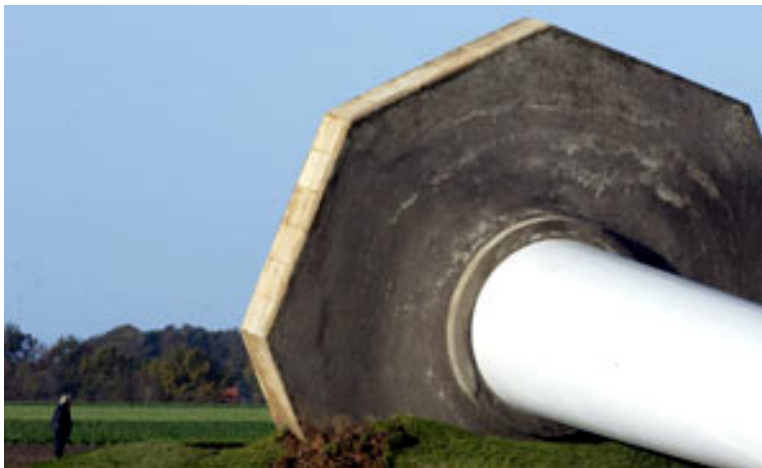
Figure 16. A 70-meter or 230-feet high tower collapsed in inclement weather at Goldenstedt, Germany, on October 28, 2002.

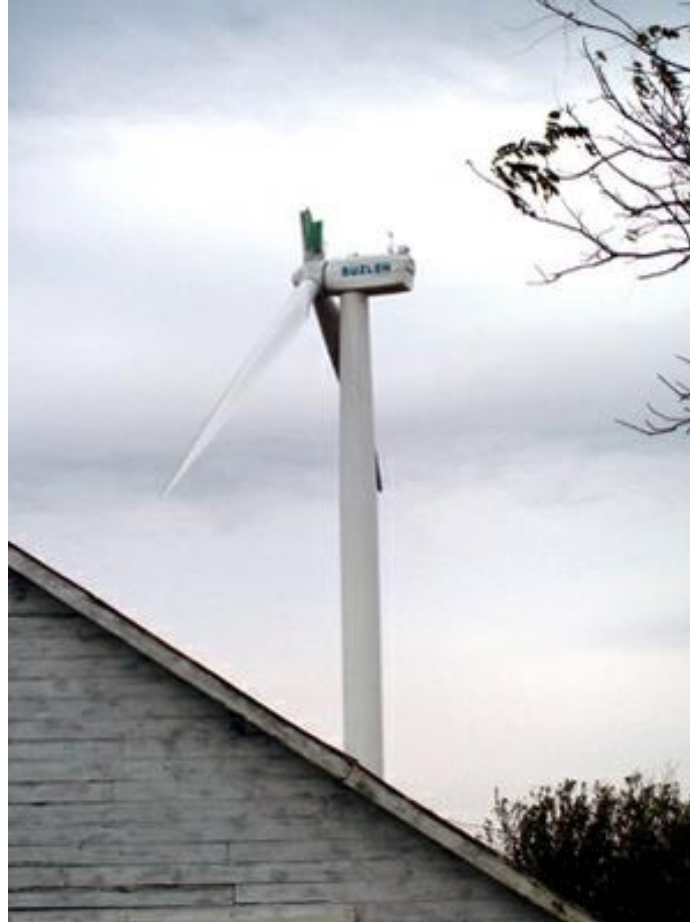
Figure 17. Blade failure at the stem on a 140 feet radius wind turbine at Wyanet, Bureau County, Illinois, October 22, 2008. The blade landed 150 feet from the base of the structural tower.

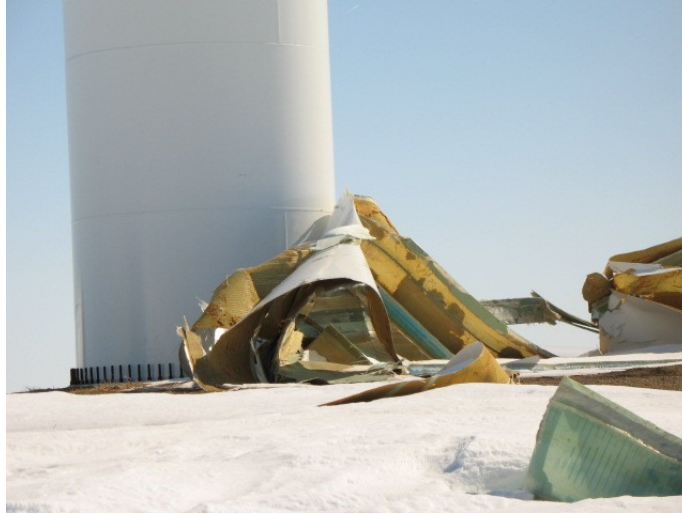
Figure 18. Turbine failure at Lake Wison, Minnesota, November 2007.

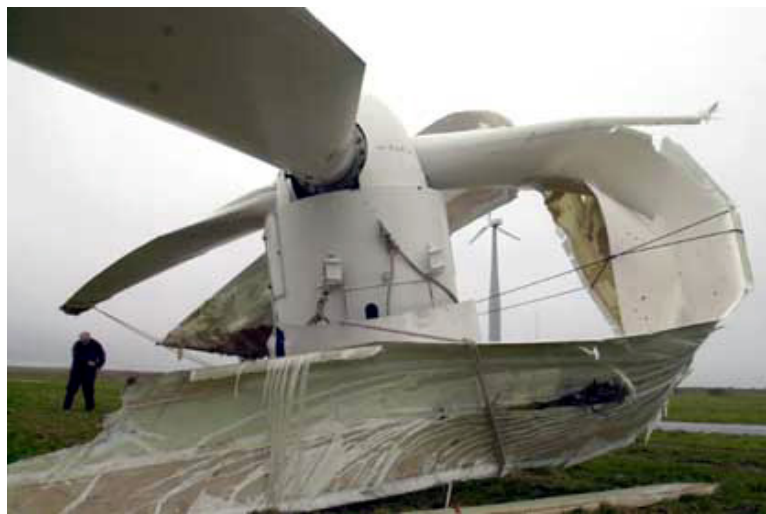
Figure 19. Structural collapse of a wind turbine in a 2002 storm. Source: Der Spiegel, DPA.

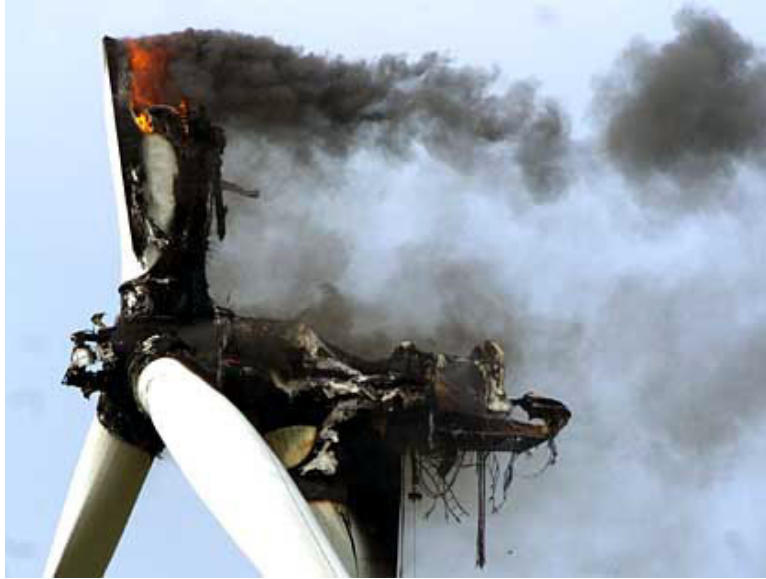
Figure 20. Fire caused by a short circuit, frictional overheating or lightning in 2004 in Germany. Source: Der Spiegel, DPA.

Short circuits, overheated alternators or gearboxes oil have caused fires.

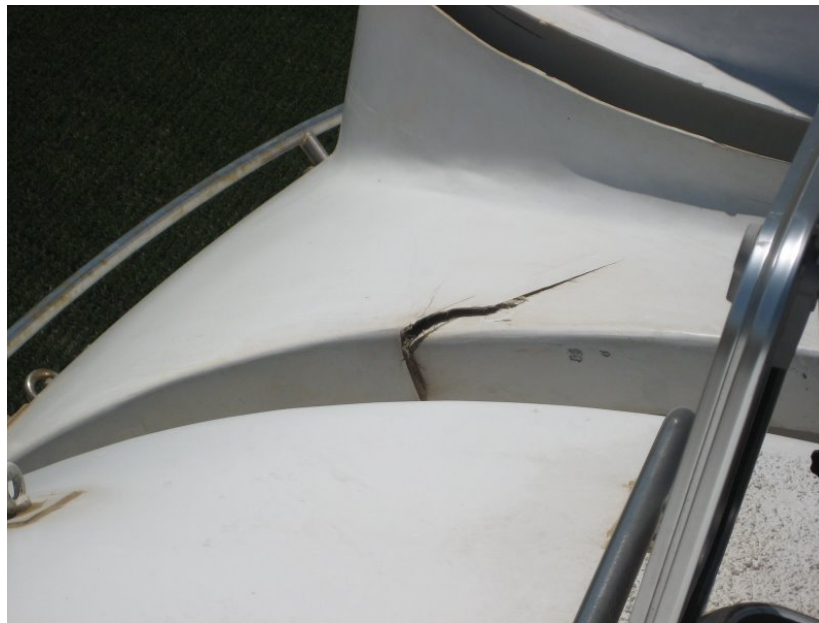
Figure 21. Structural crack near the hub of a wind turbine.

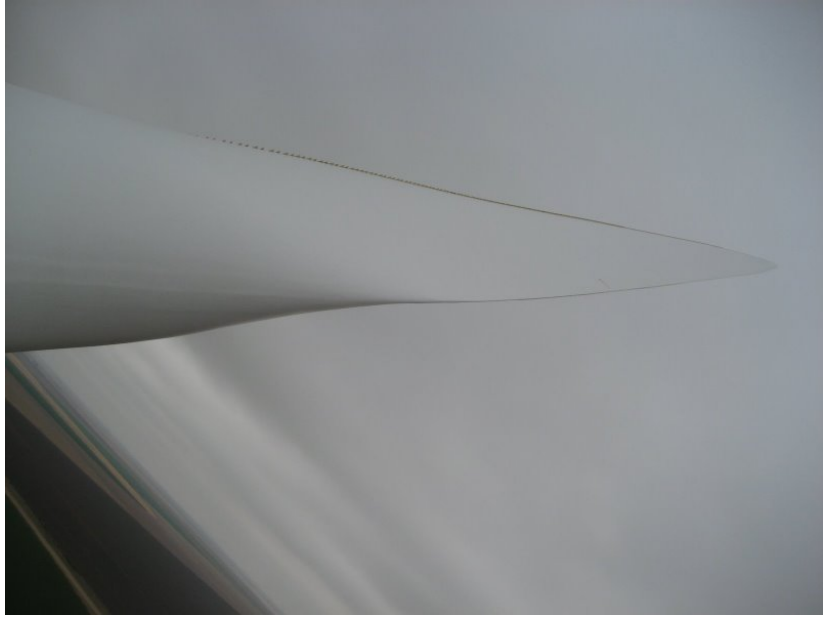
Figure 22. Structural crack caused by manufacturing defect in a rotor blade.

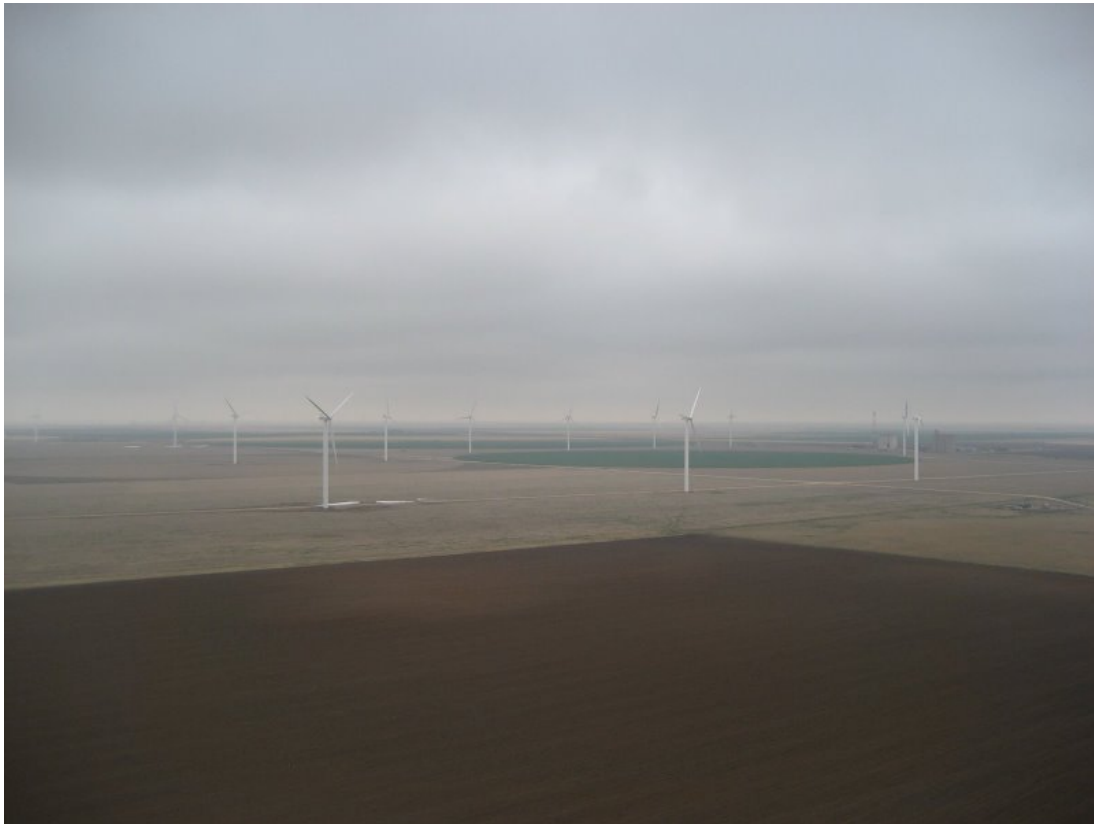
Figure 23. Recall and replacement of rotor blades in a wind farm due to a manufacturing defect, USA.

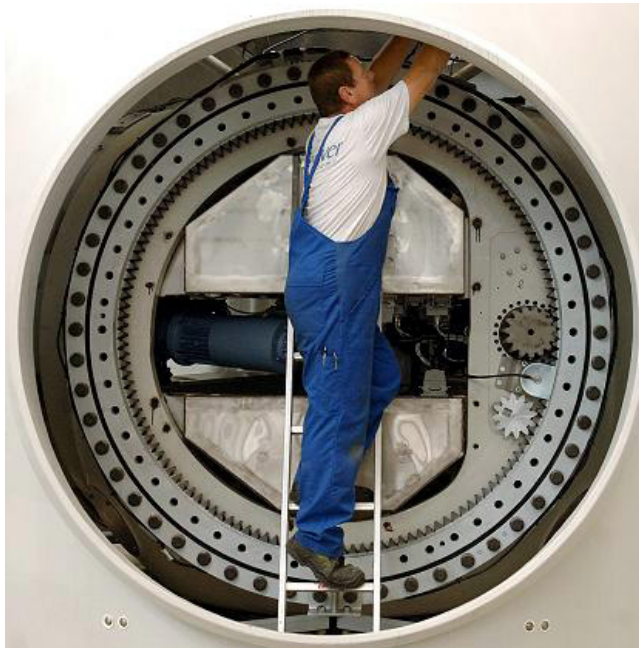
Figure 24. The gear boxes of wind turbines need replacement every five years, as they are the component that is most prone to failure from wind gusts causing misalignment of the drive train. Source: Der Spiegel, DPA.

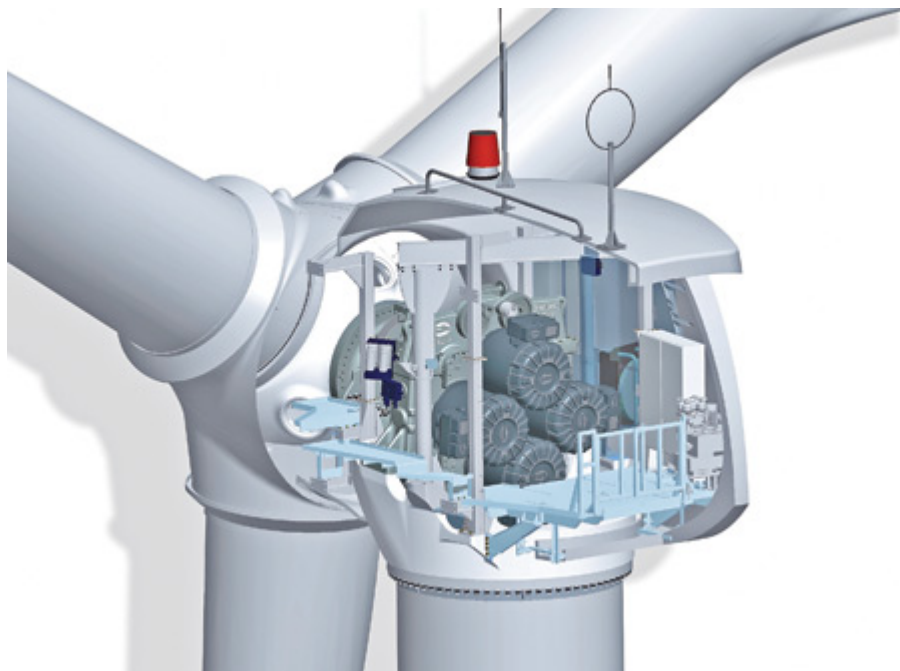
Figure 26. Torque splitting between four electrical generators operated in parallel. The turbine can continue operation with one generator out of service. Source: Clipper Wind Power Inc.

The turbines use a unique approach in their gearboxes to cope with the large torque generated by the turbine blades that are longer than the wing of a Boeing 747 airplane on the gear box. The drive train of the wind turbine uses torque splitting and feed it into four turbo generators operating in parallel. An advantage is that the turbine can continue operation with one generator out of service and waiting for repair.

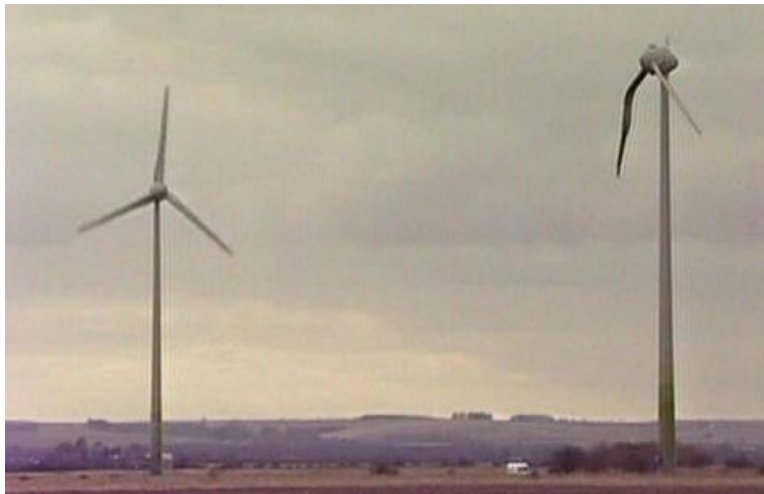
Figure 28. Blade failure due to possible ice shedding from one blade unto another or a manufacturing defect, Conisholme, Lincolnshire, UK.

Refusing to recognize ice shedding or structural manufacturing defects as causes of failure, UFO enthusiasts had their fun claiming that the damage to a Lincolnshire wind farm turbine was caused by a mystery aircraft. The turbine at Conisholme lost one 66 ft

or 20 meters blade and another was badly damaged. The turbine was one of 20 at the Conisholme site, which has been fully operational since April 2008.

If the turbine blade were still, it would take the equivalent of a 10 tonne load to cause such damage, but if it were rotating, or hit by a moving object, the force could be significantly less. It definitely was not a bird hit, but it could be ice thrown from a neighboring rotor blade that struck it. Most turbines have an anti icing system on the blades and maybe it failed to prevent the ice build-up."

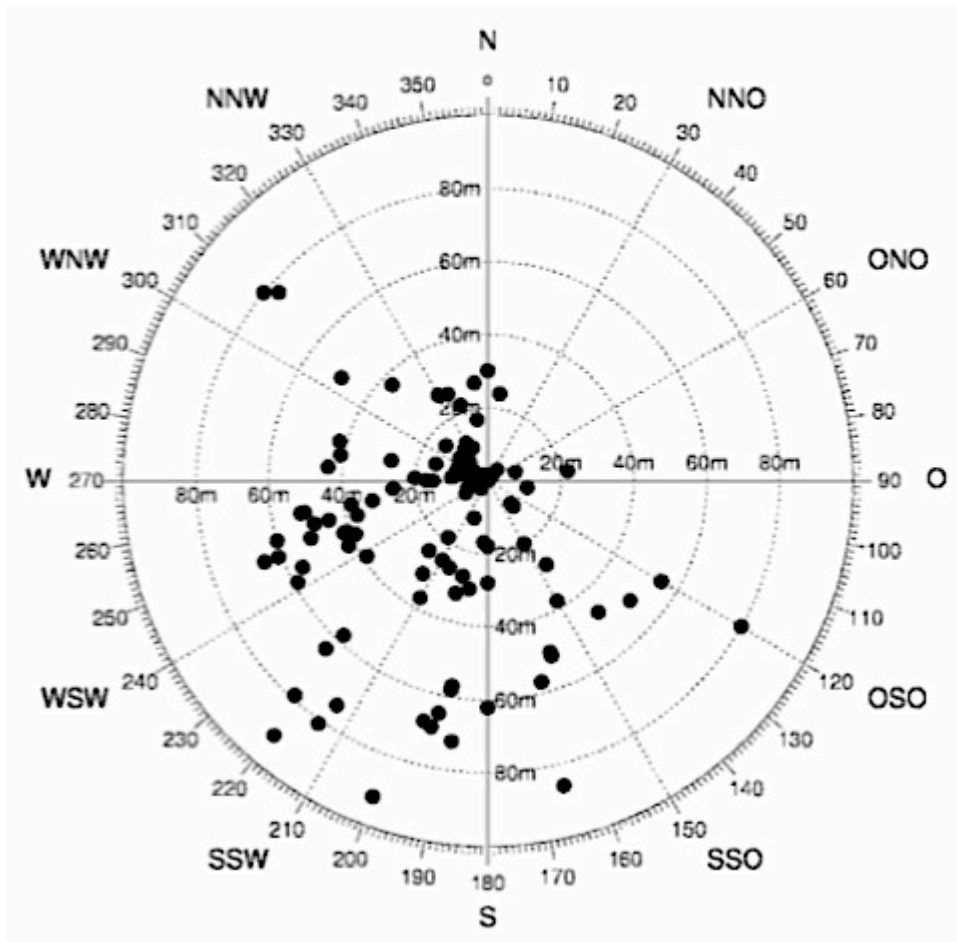
Figure 29. Frequency of an ice throw study in the Swiss Alps. Ice throws depend on the prevailing wind conditions and can reach a distance of 100 meters from the base of the wind turbine.

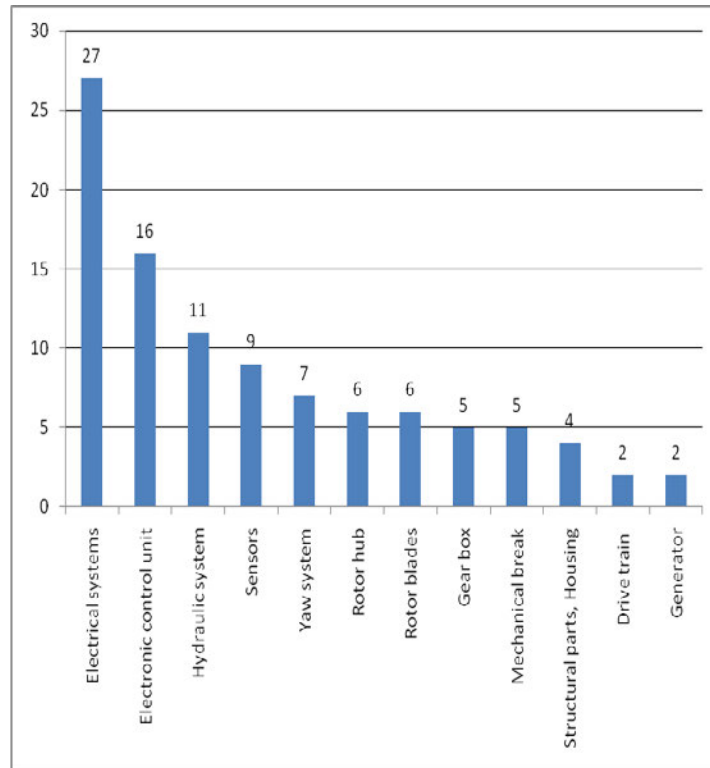
Figure 31. Percentage of needed repairs and maintenance on utility scale wind turbines. Data: AWEA.

Most of the repairs in occur in the electrical and electronic controls and the sensors units. The mechanical breakdowns are smaller in incidence but have more serious effects affecting the downtime of turbines.
